CAPE ROYAL ROAD
(Grand Canyon Route #3)
(Point Imperial-Cape Royal Road)
Between North Entrance Road and Cape Royal
Grand Canyon National Park
Coconino County
Arizona

HAER No. AZ-40

CAPE ROYAL ROAD
(Grand Canyon Route #3)
(Pt. Imperial-Cape Royal Road)
HAER No. AZ-40

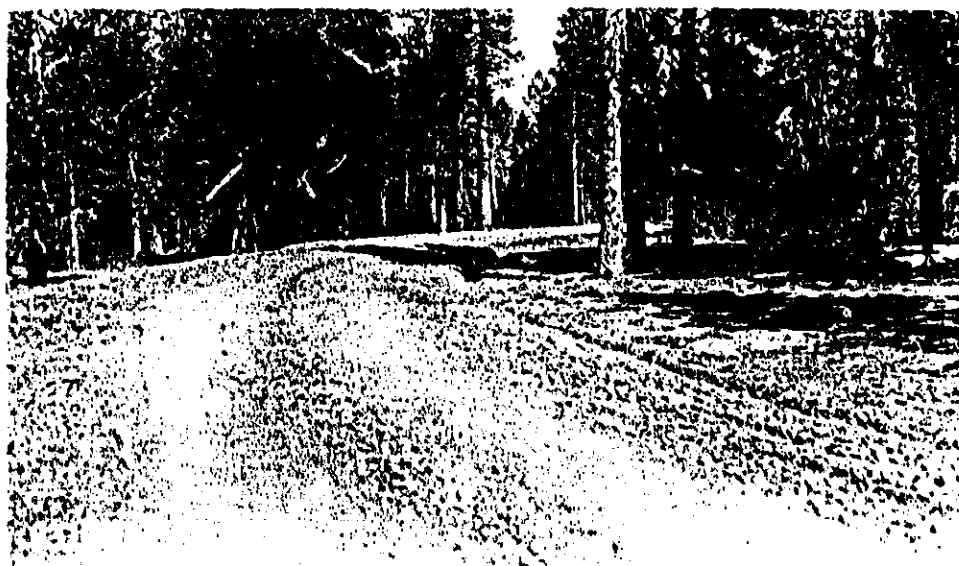
Figure 3. Completed roadway at Station 518+00, ca. 1929. (construction reports, GCSC)

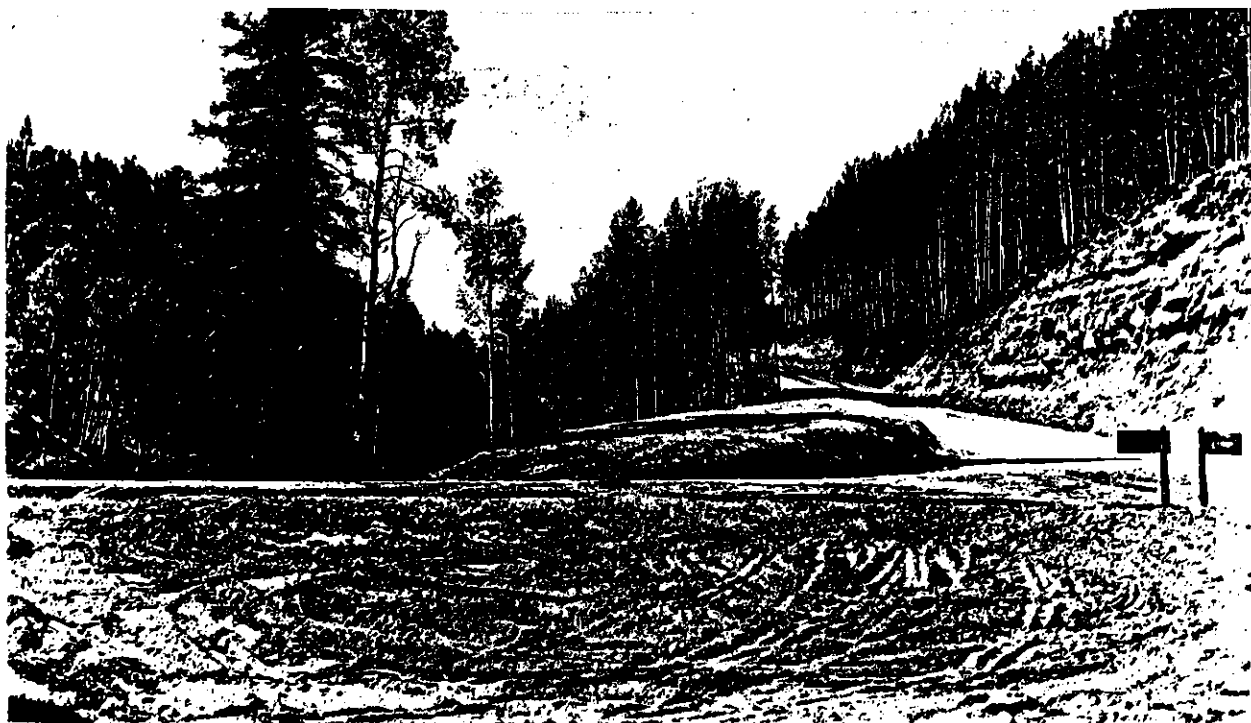
Figure 5. Completed intersection. (GRCA Image #3946, GCSC)

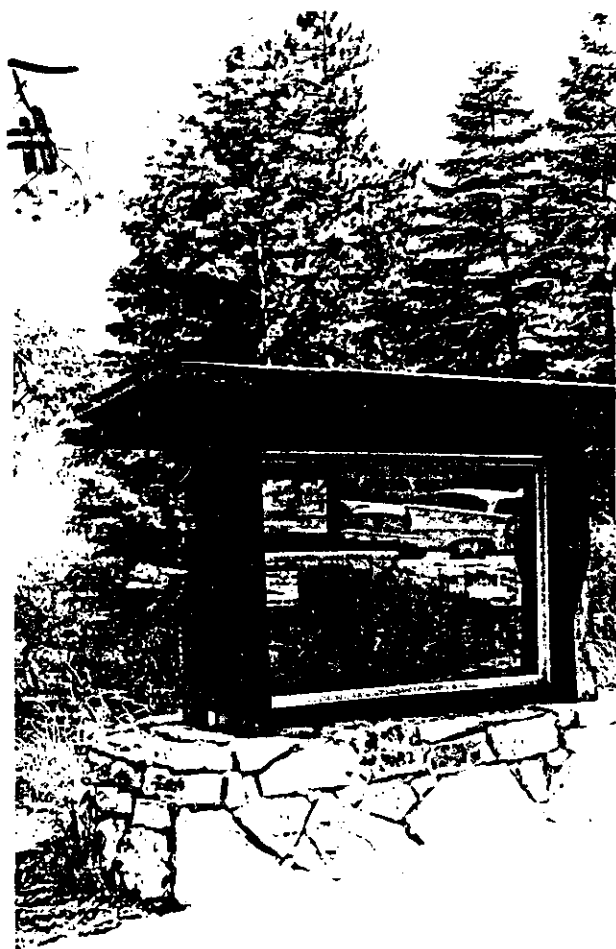
Figures 13-14. Masonry and wood interpretive monuments and glass-enclosed signs along Cape Royal Road, July 1962.
